**Flood Control Project Maintenance
Levee Inspections****LMA District Cover Sheet****Spring 2013 Levee Inspection Results****Reclamation District No. 2103 Wheatland Vicinity**

Levee Inspection Report By Mile - Spring 2013

Reclamation District No. 2103 Wheatland Vicinity

Waterway				Bank	Unit Miles	Inspection Start/End	Inspector	
Unit No. 01 South Dry Creek				Left	4.77	04/30/2013 04/30/2013	Rick Burnett

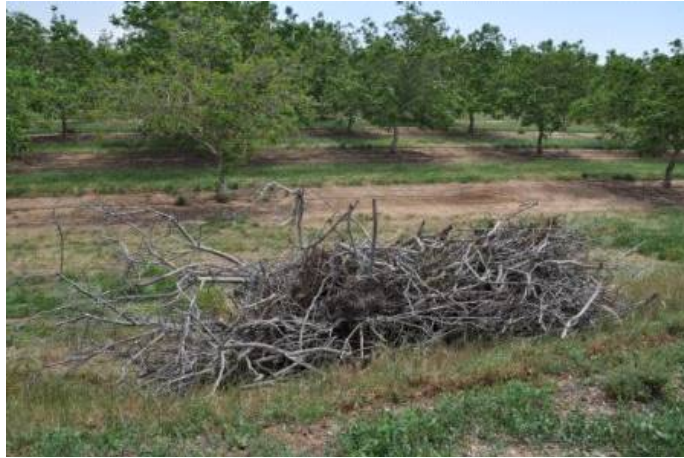
Levee Mile Report Line	4
Start Levee Mile	0.73
End Levee Mile	0.73
Location	Land Side
Category	
Item	Encroachments
L/S slope pruning pile.	
rburnett_s_20130430_313.JPG

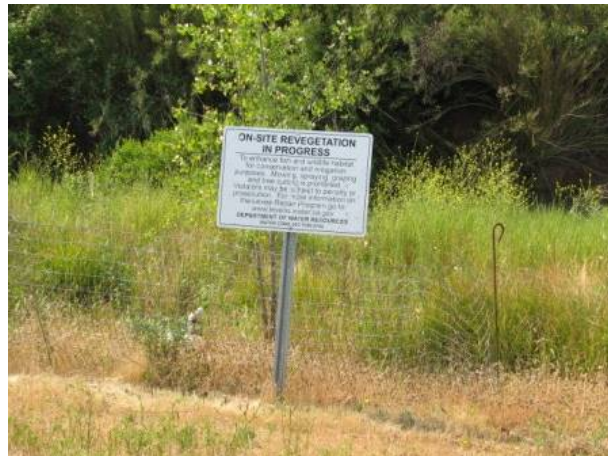
Levee Mile Report Line	2
Start Levee Mile	0.33
End Levee Mile	0.50
Location	Water Side
Category	
Item	Vegetation
Levee mile 0.33, this photo is looking at the landscaping, vegetation on the waterside slope	
jhirabay_s_20130314_211.jpg

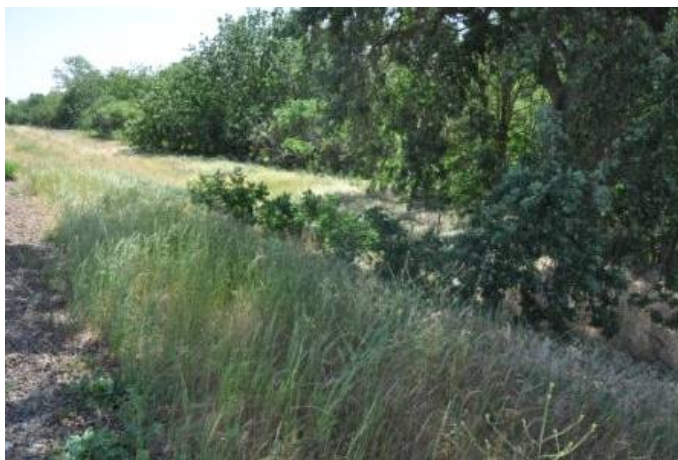
Levee Mile Report Line	3
Start Levee Mile	0.65
End Levee Mile	0.65
Location	Land Side
Category	
Item	Trim / Thin Trees
Saplings and low hanging limbs on W/S slope.	
rburnett_s_20130430_307.JPG

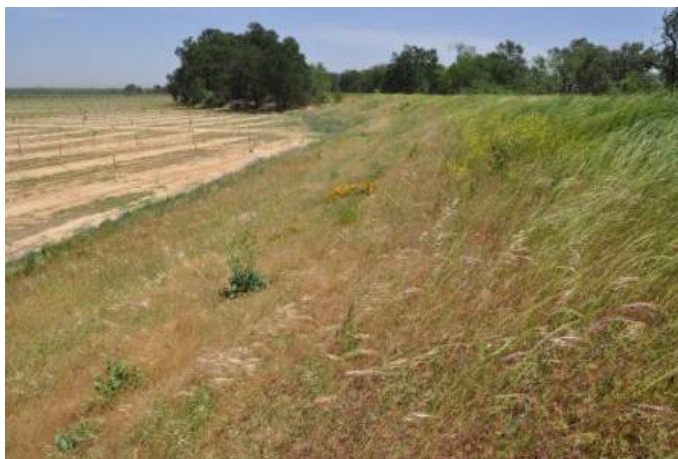
Levee Mile Report Line	4
Start Levee Mile	1.85
End Levee Mile	2.72
Location	Land Side
Category	
Item	Vegetation
Typical seasonal vegetation on L/S slope.	
rburnett_s_20130430_306.JPG

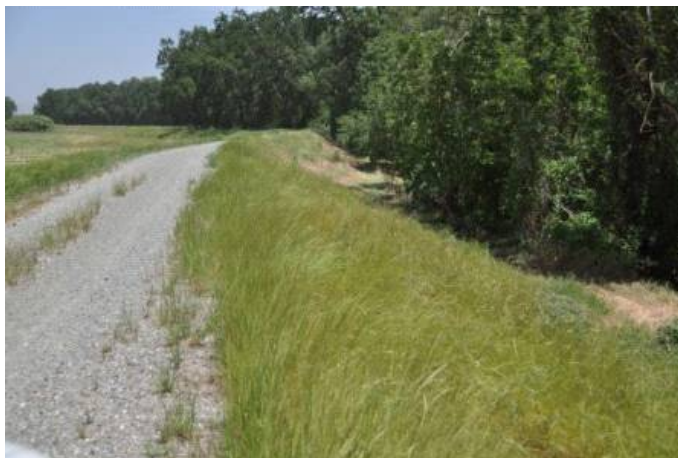
Levee Mile Report Line	5
Start Levee Mile	1.85
End Levee Mile	2.72
Location	Water Side
Category	
Item	Vegetation
Typical vegetation on the W/S levee .slope	
rburnett_s_20130430_308.JPG

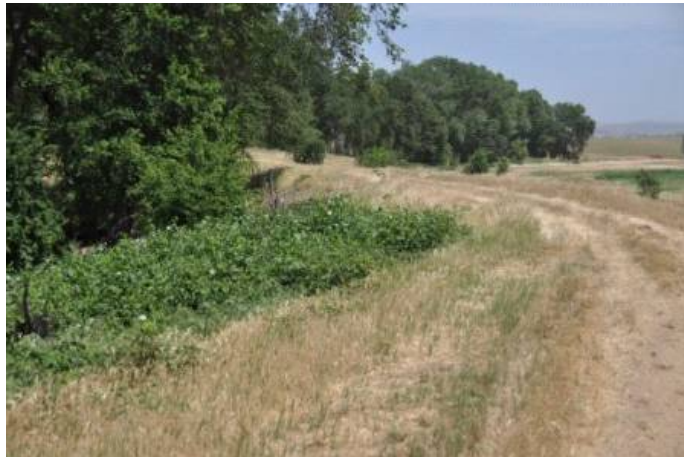
Levee Mile Report Line	7
Start Levee Mile	4.88
End Levee Mile	4.99
Location	Land Side
Category	
Item	Vegetation
L/S slope vegetation near end of levee.	
rburnett_s_20130430_310.JPG
